Contract #: 04-0120F4Cty: SF/ALA Rte: 80 PM: 13.2/13.9File #: 01.28**WELDING INSPECTION REPORT****Resident Engineer:** Casey, William**Address:** 333 Burma Road**City:** Oakland, CA 94607**Report No:** WIR-029919**Date Inspected:** 16-Aug-2013**Project Name:** SAS Superstructure**OSM Arrival Time:** 700**Prime Contractor:** American Bridge/Fluor Enterprises, a JV**OSM Departure Time:** 1730**Contractor:** American Bridge/Fluor Enterprises, a JV**Location:** Job Site

Tower Skirt Ring Beam

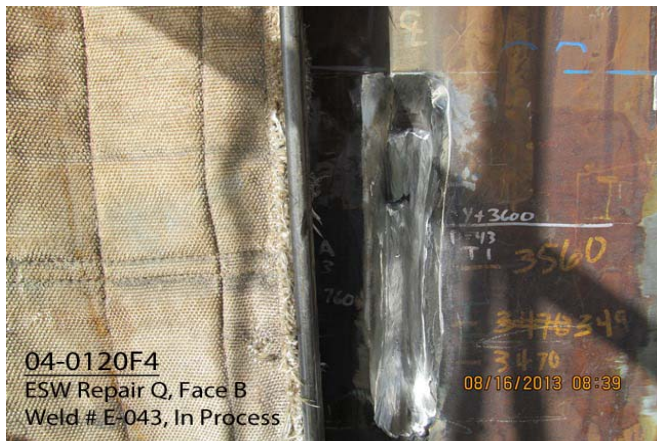
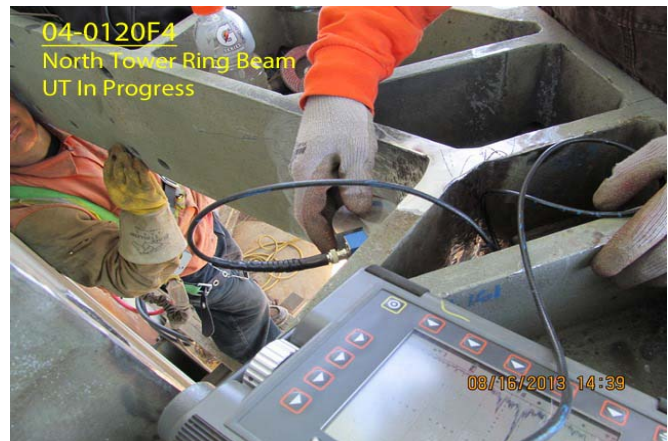
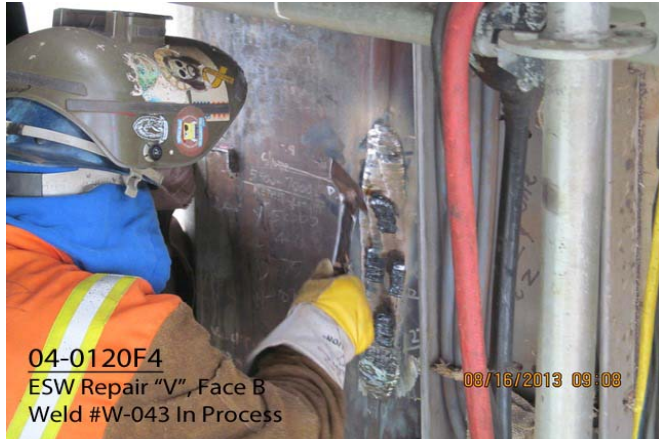
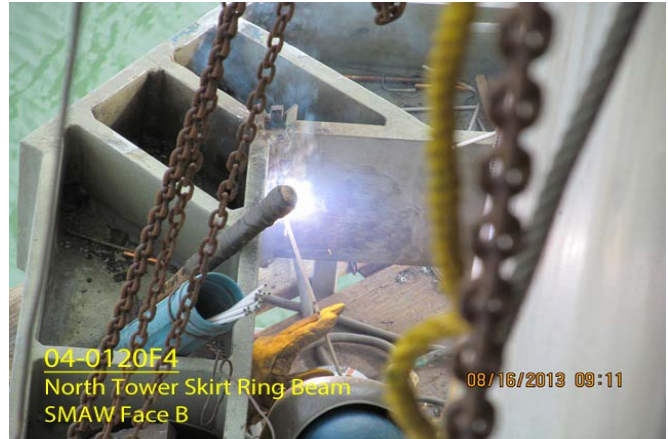
The welding & workmanship observed on this date appeared to be in general compliance with the contract specifications. The following pictures below detail some of the observations made on this date.
